## RESTORATION OF SAND DUNE VEGETATION FROM CUDDALORE AREA, SOUTHEAST COAST OF INDIA

M.P.Arulmoorthy\*, M.Srinivasan<sup>1</sup>

<sup>1,2</sup> Centre of Advanced Study in Marine Biology, Faculty of Marine Sciences, Annamalai University,  
Parangipettai – 608 502 Tamil Nadu, India

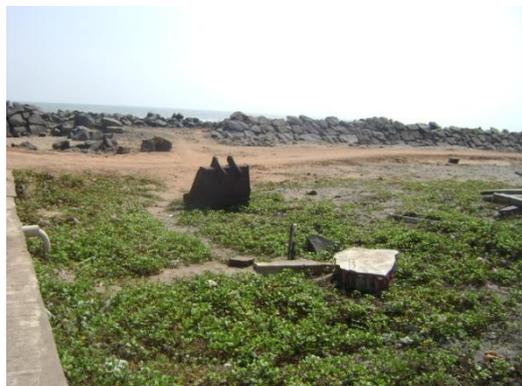
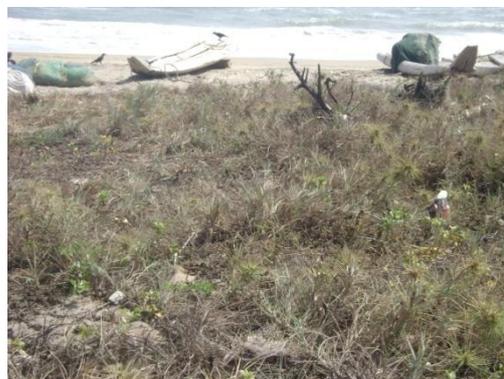
**Fig:1** Sand dune with *ipomea pescaprae* affected by the artificial shield build by humans

**Fig:2** *spinifex littoralis* destruction due to human impact

Field investigation and the preliminary assessment in the Cuddalore coastal villages indicate the sand dunes were in the immense pressure. In *Devanampattinam* (11°44'39" N and 79°47'00" E) totally 12 sand dunes were surveyed, in this 6 to 7 dunes are without any sand dune plants and are in the stage of extinct (Fig :1,2). In *thazhanguda* (11°46'02" N and 79°47'27" E) totally 5 dunes were surveyed, in this all Sand dunes

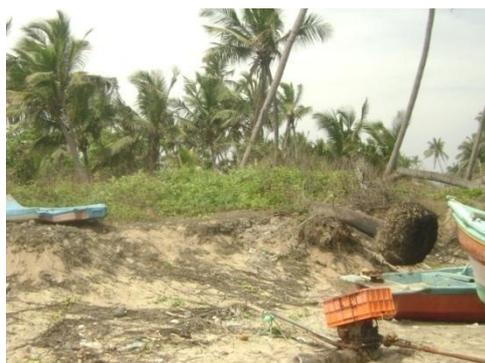
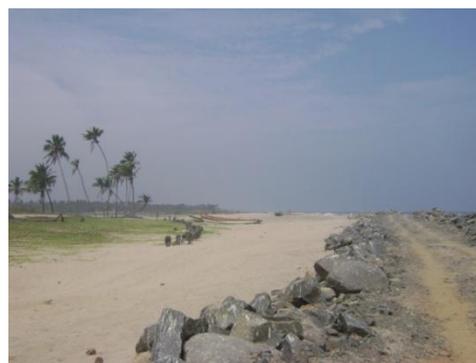
**Fig:3** Sand dune destroyed by the cyclone "thane"

**Fig:4** sand dune destructed by human impact

are without any vegetation (Fig:3, 4). In *singarathoppu* (11°43'26" N and 79°46'57" E) and *pudupettai* (11°30'59" N and 79°46'09" E) 12 sand dunes were surveyed in this mostly all sand dunes in *singarathoppu* with high vegetation of ipomea and spinifex (Fig: 5, 6) and in pudupettai due to the thermal power plant construction all sand dunes are destructed and polluted by the humans (Fig: 7, 8). *Annangkovil* (11°30'08" N and 79°46'19" E) nearly all

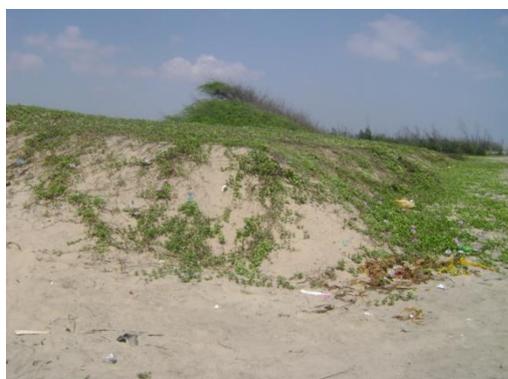
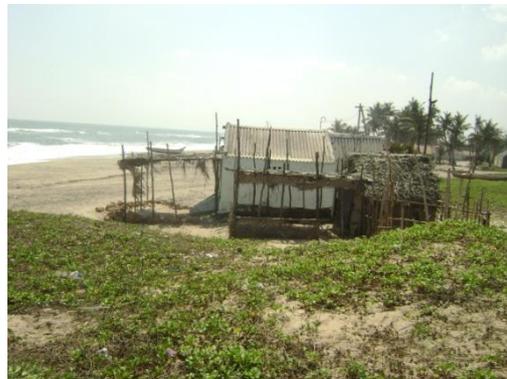
**Fig:5** Sand dune with *ipomea pescaprae*

**Fig:6** sand dune with temple

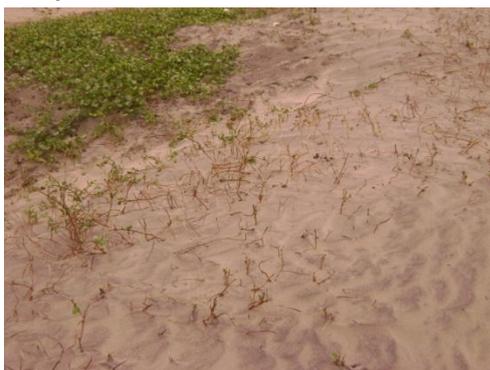
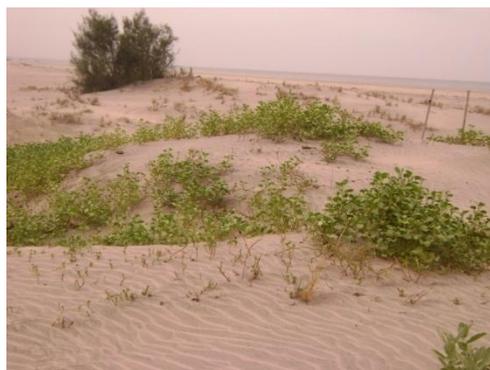
**Fig:7** Grazing of *ipomea pescaprae* in sand dune

**Fig:8** sand dune with *cashewrina* and *ipomea*

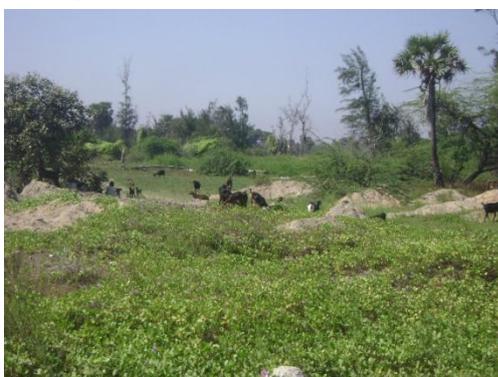
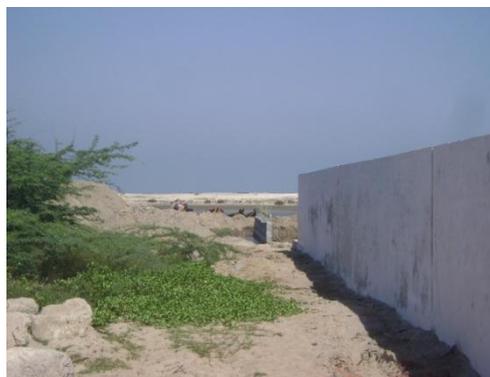
**Fig:9** Grazing of *ipomea pescaprae* by the cattles in sand dunes

**Fig:10** Destruction of sand dunes by harbor construction

sand dunes are disturbed by harbor construction with poor vegetation (**Fig: 9, 10**).

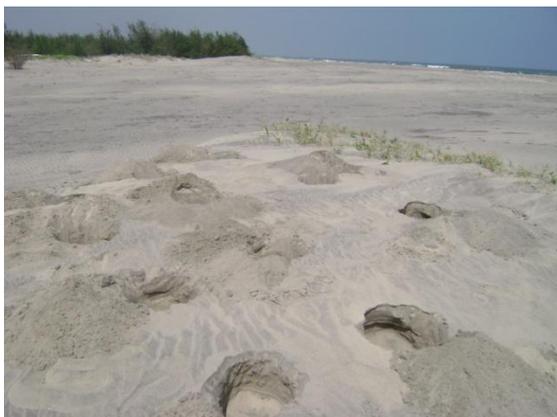
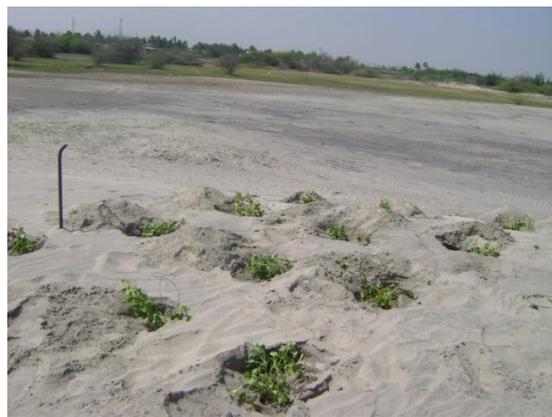
area i.e., two to three meter length of *ipomea pescaprae* were plucked and cut into small plants by giving two to three internodes and planting it in pits dug at a depth of 30 to 40 cm. The planting of creepers was made at an interval of 2 m distance each in 6 pits. For one site an area of 16 m X 16 m was covered with fence. Watering the plants and fencing were followed after the planting.

**Fig:11** Dugging of pits

**Fig:12** Planting ipomea pescaprae

Restoration works were carried out in five coastal villages in Cuddalore from the month October 2012 (**Fig: 11, 12, 13, and 14**). *Ipomea pescaprae* and *Spinifex littoralis* are the plant species restored in these villages by plucking a portion of the creeper from the denser area and planting it in pits dug at a depth of 30 to 40 cm. The planting of creepers was made at an interval of 2 m distance each in 6 pits. 90% of growth was recorded in my study from the month of October 2012 to January 2013. *Ipomea pescaprae* growth was reached nearly 30 cm from three months but *Spinifex littoralis* was not showing any level of growth. After two months, fencing of the vegetated sand dunes were made particularly in

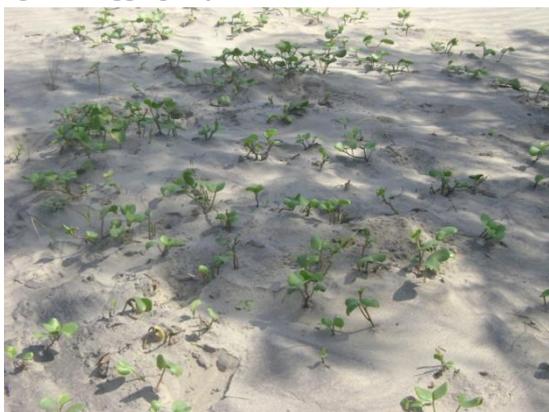
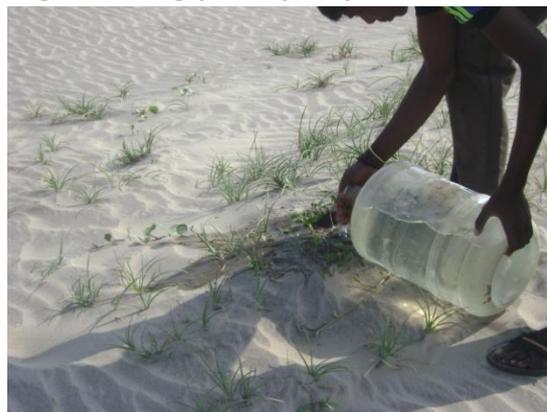
**Fig:13** Twenty days growth

**Fig:14** Watering to ipomea and spinifex

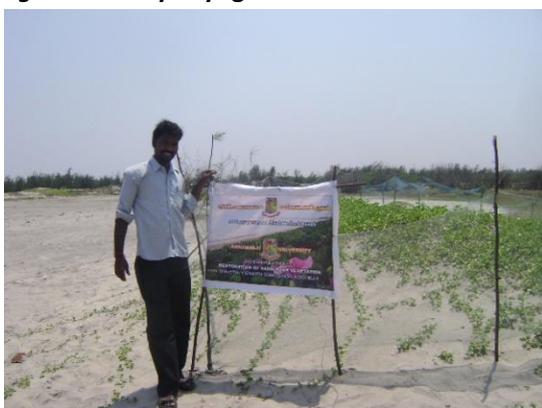
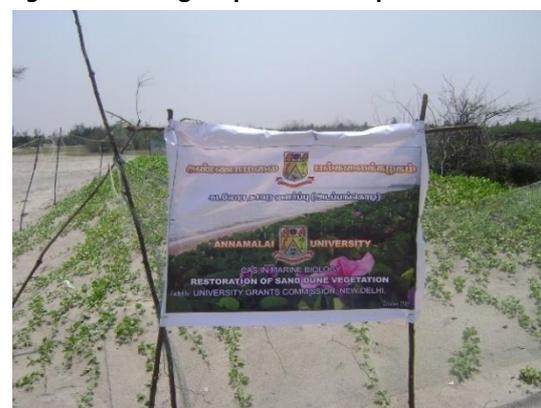
**Fig: 15, 16** Fencing of ipomea vegetated sand dunes in pudupettai and singarathoppu villages

pudupettai and singarathoppu villages (**Fig: 15, 16**). The table (**Table: 1, 2**) shows the growth rate of *Ipomea pescaprae* and *Spinifex littoralis* for the three months in the five villages.
