RESTORATION OF SAND DUNE VEGETATION FROM CUDDALORE AREA, SOUTHEAST COAST OF INDIA

ABSTRACT

This paper aims to generate a restoration of *Ipomoea pescaprae* and *Spinifex littoralis* on coastal sand dune in the coramandal coast, with special reference to Cuddalore coastline. Apparently, this is the first sand dune restoration work carried out in Cuddalore coast.

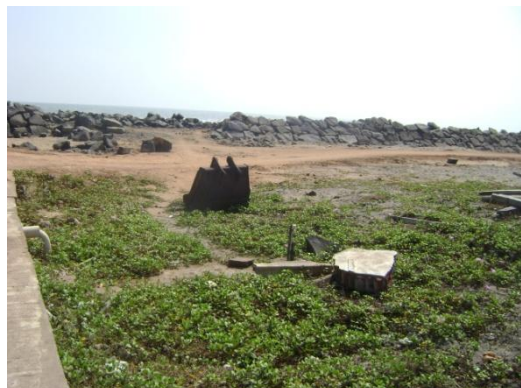
Fig:1 Sand dune with *ipomea pescaprae* affected by the artificial shield build by humans

Field investigation and the preliminary assessment in the Cuddalore coastal villages indicate the sand dunes were in the immense pressure. In *Devanampattinam* (11°44'39" N and 79°47'00" E) totally 12 sand dunes were surveyed, in this 6 to 7 dunes are without any sand dune plants and are in the stage of extinct (Fig :1,2). In *thazhanguda* (11°46'02" N and 79°47'27" E) totally 5 dunes were surveyed, in this all Sand dunes

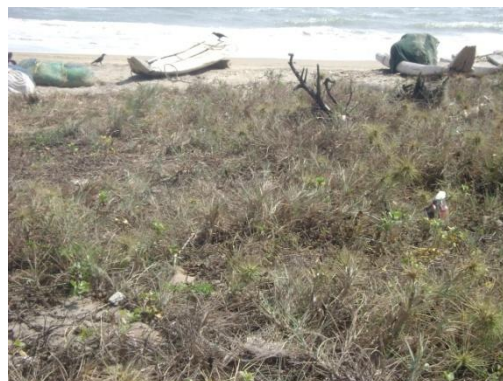
Fig:2 *spinifex littoralis* destruction due to human impact

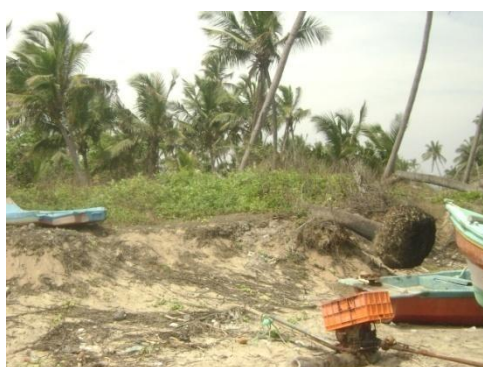
Fig:3 Sand dune destroyed by the cyclone "thane"

are without any vegetation (Fig:3, 4). In *singarathoppu* (11°43'26" N and 79°46'57" E) and *pudupettai* (11°30'59" N and 79°46'09" E) 12 sand dunes were surveyed in this mostly all sand dunes in *singarathoppu* with high vegetation of ipomea and spinifex (Fig: 5, 6) and in pudupettai due to the thermal power plant construction all sand dunes are destroyed and polluted by the humans (Fig: 7, 8). *Annangkovil* (11°30'08" N and 79°46'19" E) nearly all

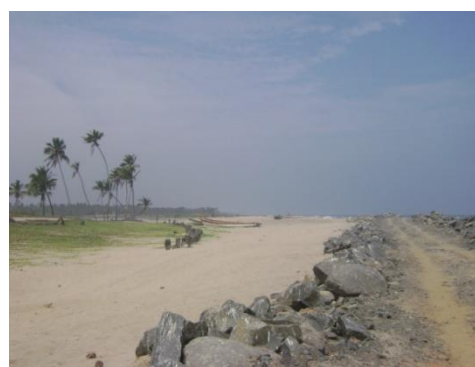
Fig:4 sand dune destructured by human impact

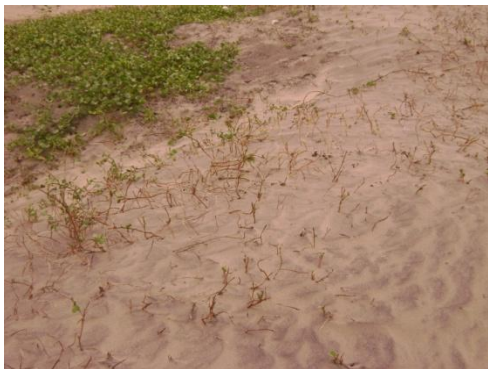
Fig:7 Grazing of *ipomea pes-caprae* in sand dune

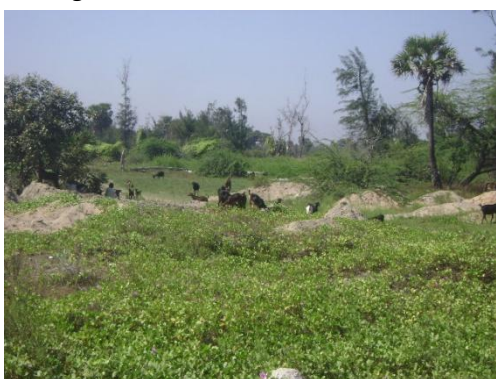
Fig:9 Grazing of *ipomea pes-caprae* by the cattles in sand dunes

sand dunes are disturbed by harbor construction with poor vegetation (**Fig: 9, 10**).

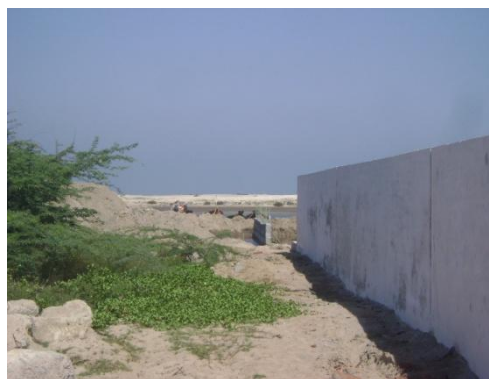
Fig:10 Destruction of sand dunes by harbor construction

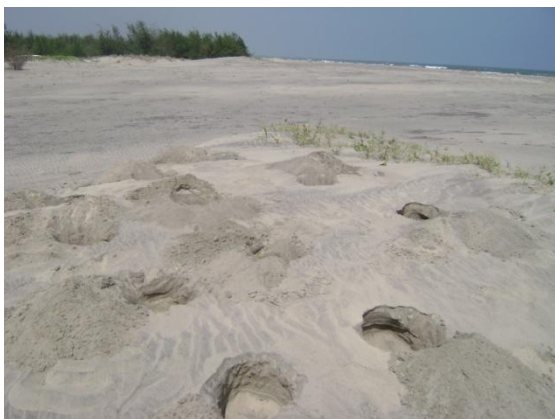
Fig:11 Dugging of pits

area i.e., two to three meter length of *ipomea pes-caprae* were plucked and cut into small plants by giving two to three internodes and planting it in pits dug at a depth of 30 to 40 cm. The planting of creepers was made at an interval of 2 m distance each in 6 pits. For one site an area of 16 m X 16 m was covered with fence. Watering the plants and fencing were followed after the planting.

Restoration works were carried out in five coastal villages in Cuddalore from the month October 2012 (**Fig: 11, 12, 13, and 14**). *Ipomea pescaprae* and *Spinifex littoralis* are the plant species restored in these villages by plucking a portion of the creeper from the denser area and planting it in pits dug at a depth of 30 to 40 cm. The planting of creepers was made at an interval of 2 m distance each in 6 pits. 90% of growth was recorded in my study from the month of October 2012 to January 2013. *Ipomea pescaprae* growth was reached nearly 30 cm from three months but *Spinifex littoralis* was not showing any level of growth. After two months, fencing of the vegetated sand dunes were made particularly in

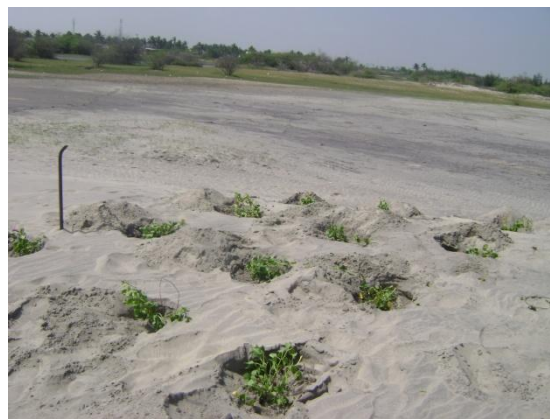
Fig:12 Planting ipomea pescaprae

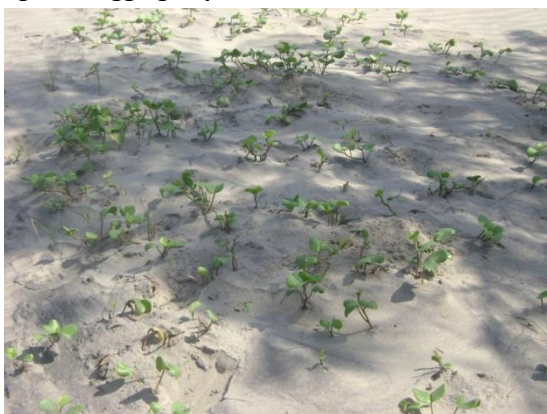
Fig:13 Twenty days growth

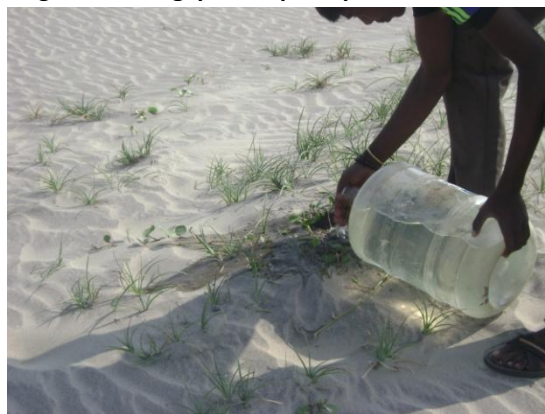
Fig:14 Watering to ipomea and spinifex

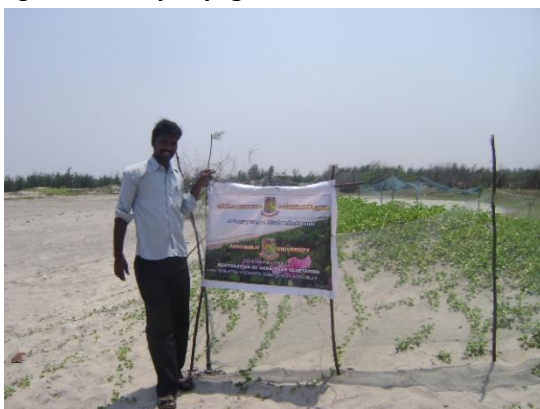
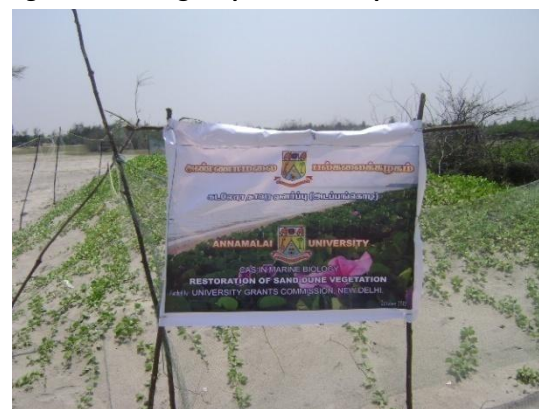
Fig: 15, 16 Fencing of ipomea vegetated sand dunes in pudupettai and singarathoppu villages

pudupettai and singarathoppu villages (**Fig: 15, 16**). The table (**Table: 1, 2**) shows the growth rate of *Ipomea pescaprae* and *Spinifex littoralis* for the three months in the five villages.
